Contract #: 04-0120F4Cty: SF/ALA Rte: 80 PM: 13.2/13.9File #: 1.28**WELDING INSPECTION REPORT****Resident Engineer:** Casey, William**Address:** 333 Burma Road**City:** Oakland, CA 94607**Report No:** WIR-027763**Date Inspected:** 13-Jun-2012**Project Name:** SAS Superstructure**OSM Arrival Time:** 700**Prime Contractor:** American Bridge/Fluor Enterprises, a JV**OSM Departure Time:** 1530**Contractor:** American Bridge/Fluor Enterprises, a JV**Location:** jobsite**CWI Name:** Andrew Keech**CWI Present:** Yes No**Inspected CWI report:** Yes No N/A**Rod Oven in Use:** Yes No N/A**Electrode to specification:** Yes No N/A**Weld Procedures Followed:** Yes No N/A**Qualified Welders:** Yes No N/A**Verified Joint Fit-up:** Yes No N/A**Approved Drawings:** Yes No N/A**Approved WPS:** Yes No N/A**Delayed / Cancelled:** Yes No N/A**Bridge No:** 34-0006**Component:** OBG**Summary of Items Observed:**

CCO 201 Tower elevation 31 Pad eye Install

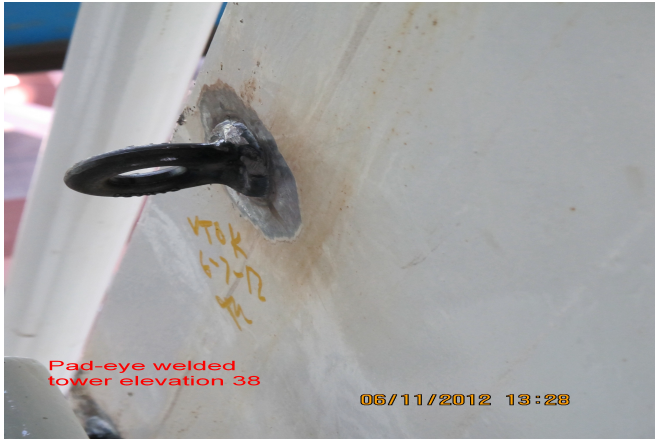
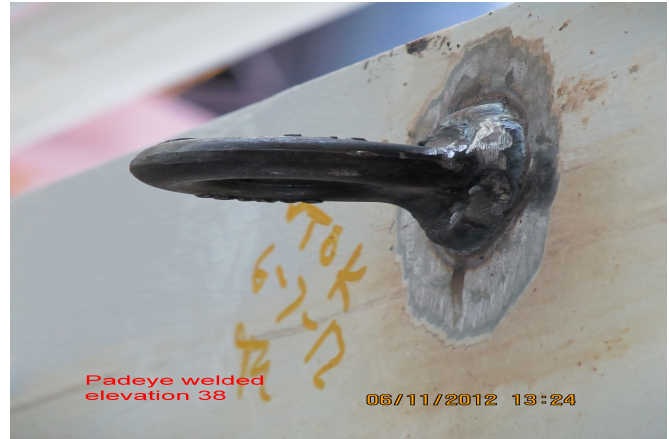
This QAI observed the removal of paint by grinding at 12 locations at Tower elevation 31. Ground areas were clean to a bright metal condition, then layout, location lines to be used during Pad eye installation were scribed on the tower columns. Per CCO 201 each 12 total Pad eyes were to be installed at elevation 31.

After grinding and layout this QAI observed the base metal being preheated to a QC recorded and QA verified temperature of 250F. The preheating was accomplished utilizing a rosebud torch using propane as fuel. Preheat was verified by this QA utilizing a Tempil Stick.

As soon as preheating operations ceased the Pad eye was attached to the tower column by Welder Rory Hogan using the Shield Metal Arc (SMAW) Process utilizing an E7018H4R consumable electrode at a QC recorded, QAI verified 123 amps.

This QAI performed Visual Weld Inspection of the 12 Pad eye to Tower Column welds completed on this date. Welds were found to meet the requirements of AWS D1.5 Bridge Welding Code Visual Inspection Criteria.
